EFFECTIVENESS OF THE SHIELDING MECHANISM IN ROOMS HOUSING X-RAY DIAGNOSTIC EQUIPMENTS (A CASE STUDY OF MULAGO HOSPITAL, UGANDA)

Festo Kiragga

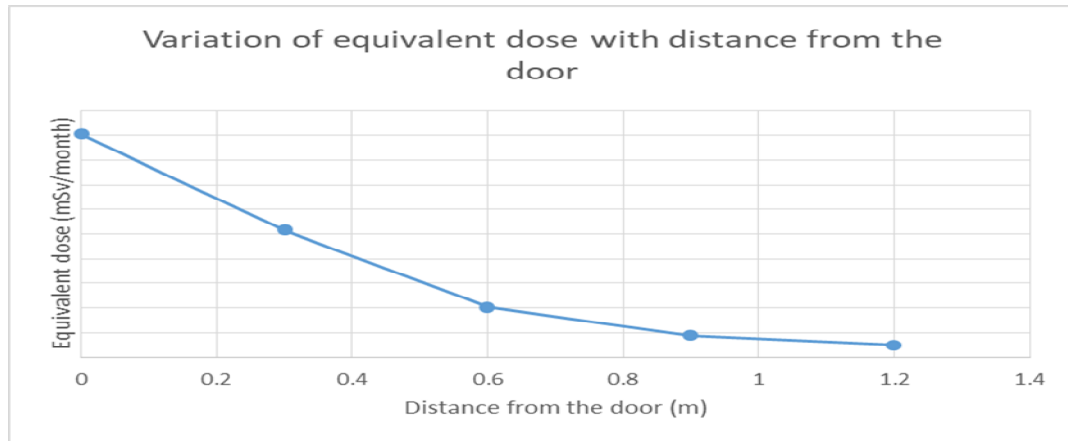
Distance from the door (m)	Equivalent dose (mSv)
0.0	18.1
0.3	10.3
0.6	4.05
0.9	1.80
1.2	1.01

The figures below show the variation of attenuated radiation with distance from the doors. The graphs indicates that closer to the doors, the Equivalent doses registered are very high. For similar exposure factors, the quantity of radiation is inversely proportional to the square of the distance from the reference point (door), that is, it follows the inverse square law. For exposures near the door, the intensity of the radiation beam is high but decreases with distance as the inverse of the square of the distance from the source. The dose rate value of 18.1 mSv/month implies that the door needs some lead lining to reduce the equivalent dose rate to an acceptable value.

Figure 1. Variation of Equivalent dose with distance from the entrance at the UCI, Mulago

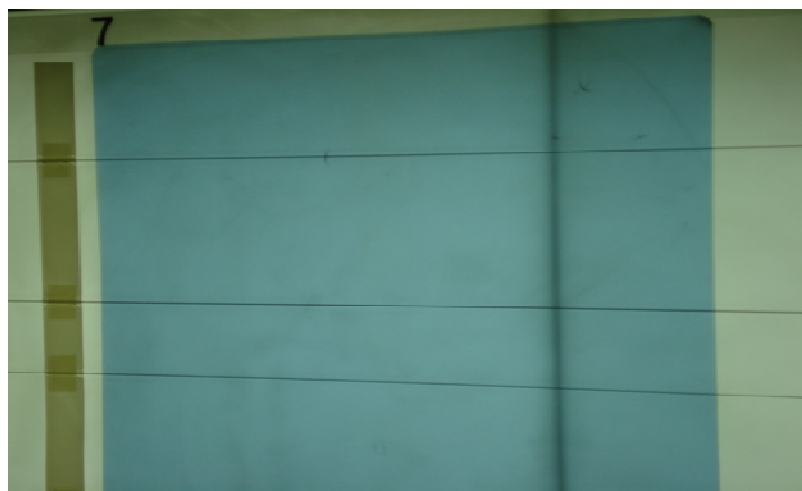
It was noted that the main shielding mechanism used by the majority of staff is the operator’s console (lead glass). The lead aprons are left to the comforters. Suspicious lead aprons from the study centers were carefully analyzed using the image viewer. However there were no cracks or faults leading to leakages were found from the exposures taken on them as shown in **Figure 2**. From **Table VIII** above, the number of protective gadgets physically present in the imaging rooms was not proportional to the actual number of staff available in the room since other lead aprons and lead skirts are kept in the store. It was noted that the main shielding mechanism used by the majority of staff is the operator’s console (lead glass). The lead aprons are left to the comforters. Suspicious lead aprons from the study centers were carefully analyzed using the image viewer. However there were no cracks or faults leading to leakages were found from the exposures taken on them as shown in **Figure 2**.

Figure 2: X-ray film of an apron from the CC showing no defects
